## **LEAD-BASED PAINT INSPECTION AND VISUAL ASSESSMENT REPORT**

2422 N Franklin St  
Colorado Springs, CO 80907

October 7, 2015

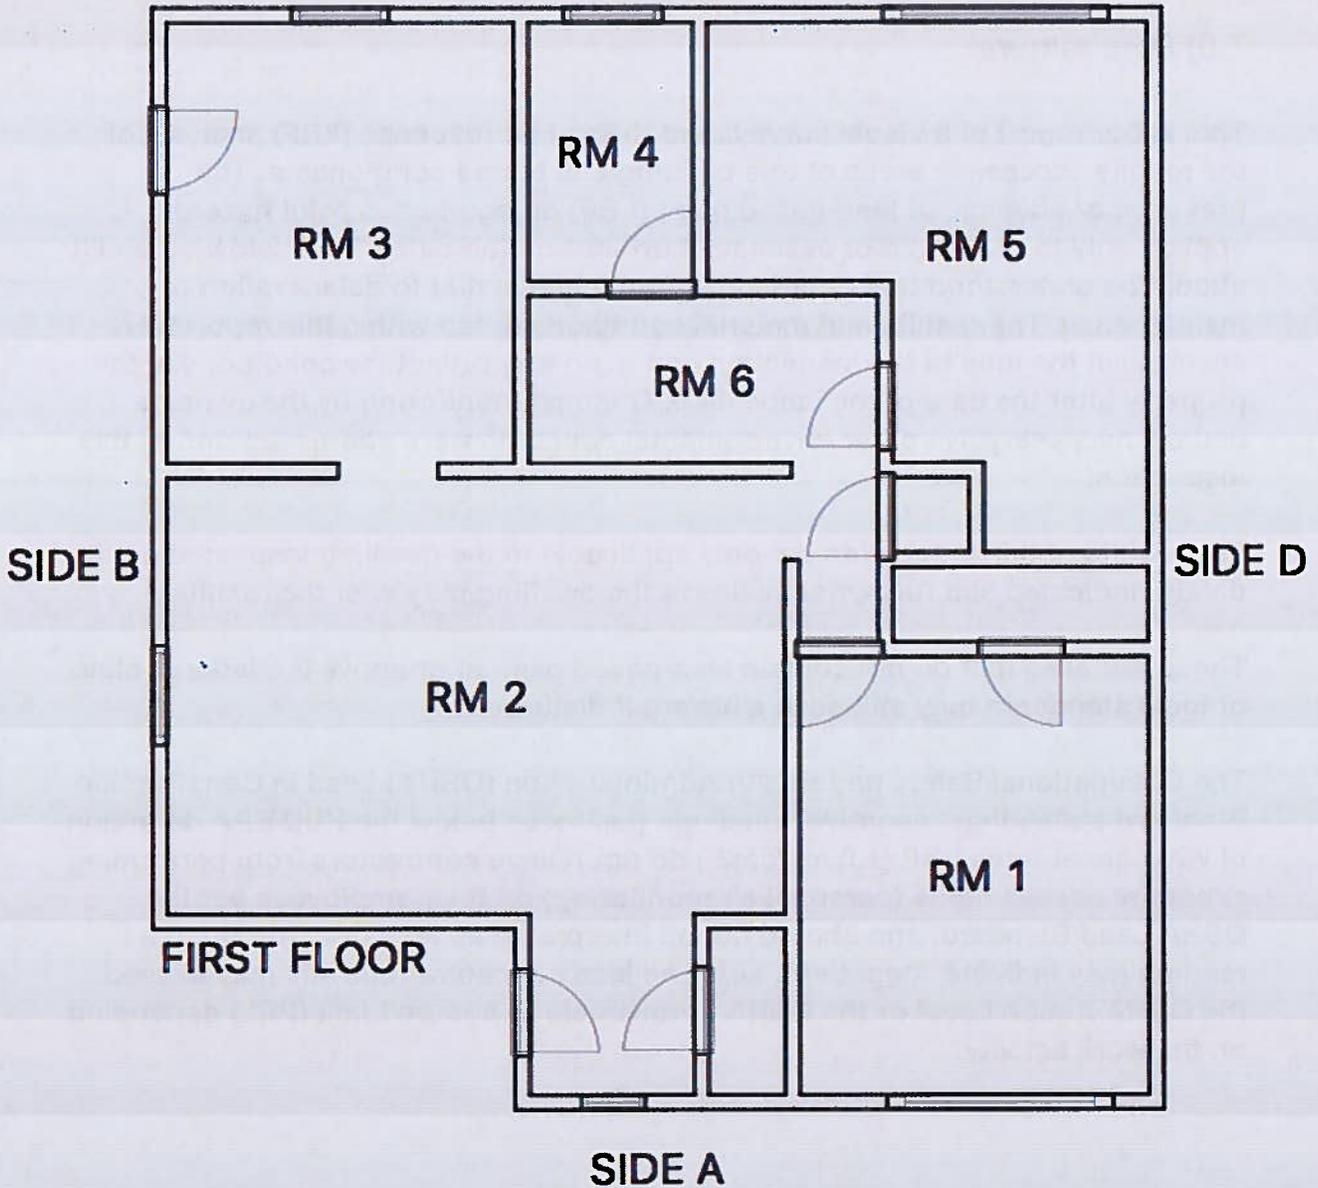
NOT TO SCALE

SIDE C

- Appendix A - Drawings/Floor Plans**
- Appendix B - XRF Data Sheets**
- Appendix C - XRF Performance Characteristic Sheets (PCS)**
- Appendix D - Certifications**
- Appendix E - Glossary**
